# RAILWAY ACCIDENT

**Report on the Accident  
that occurred on 28th February 1975  
at Moorgate Station**

**ON THE  
NORTHERN LINE  
LONDON TRANSPORT RAILWAYS**

RAILWAY INSPECTORATE,  
DEPARTMENT OF THE ENVIRONMENT,  
2 MARSHAM STREET,  
LONDON SW1.  
4th March 1976.

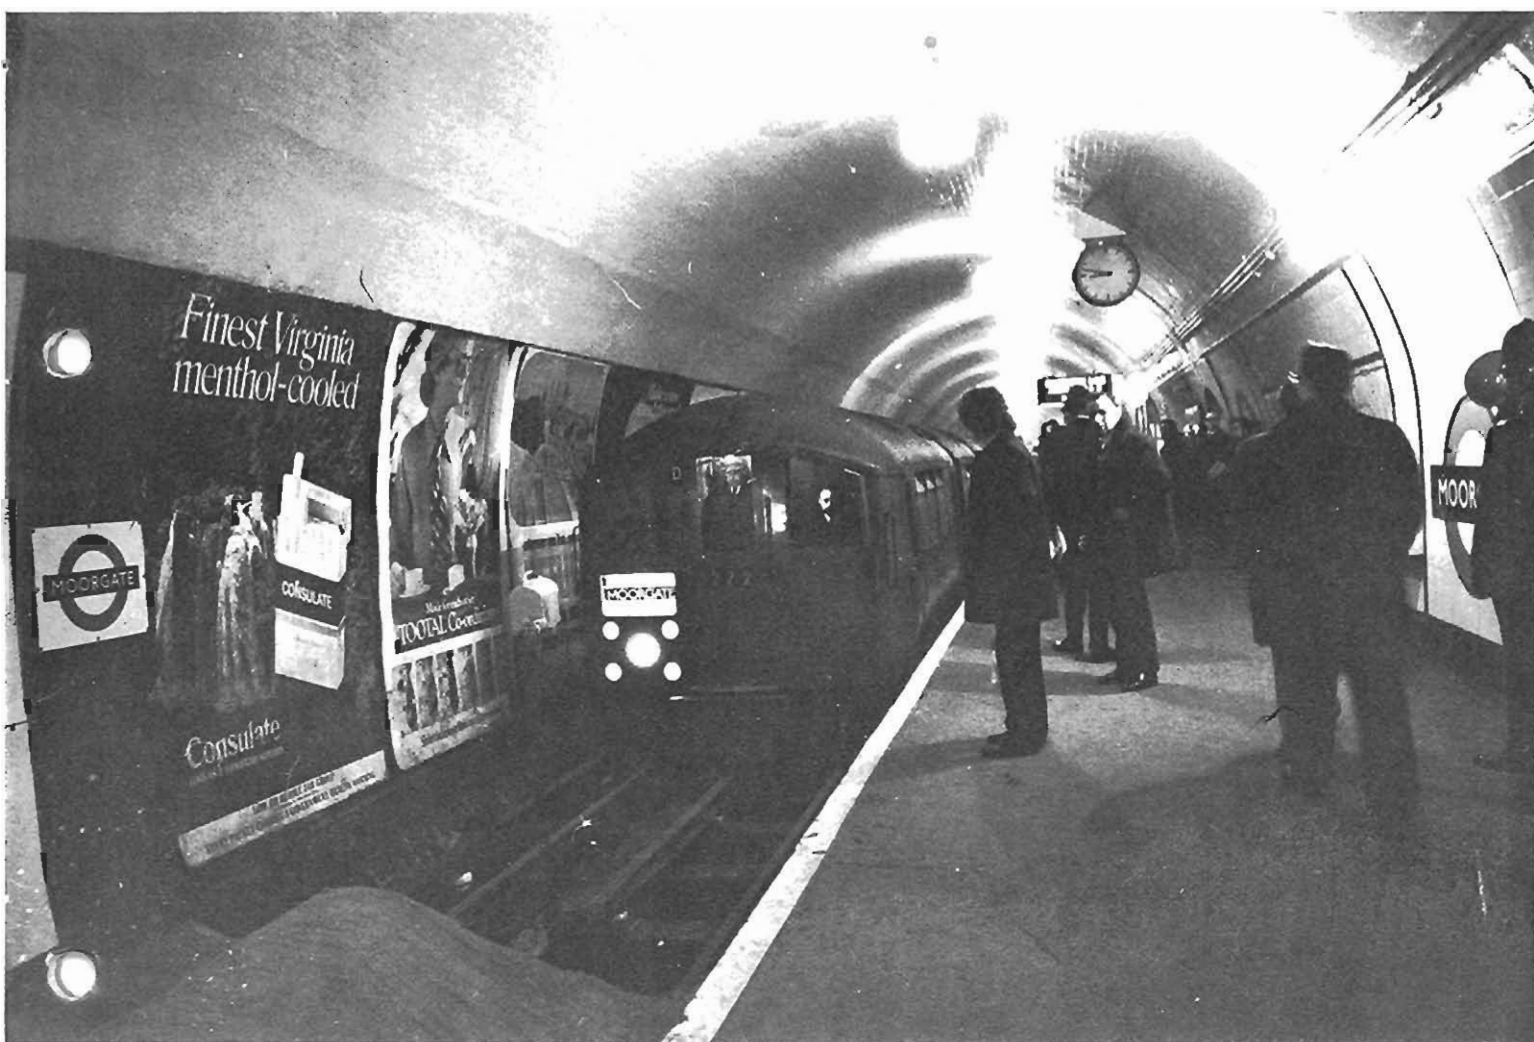
*Photograph 1. Train arriving at Platform 9 at Moorgate Station after resumption of service.  
(Press Association)*

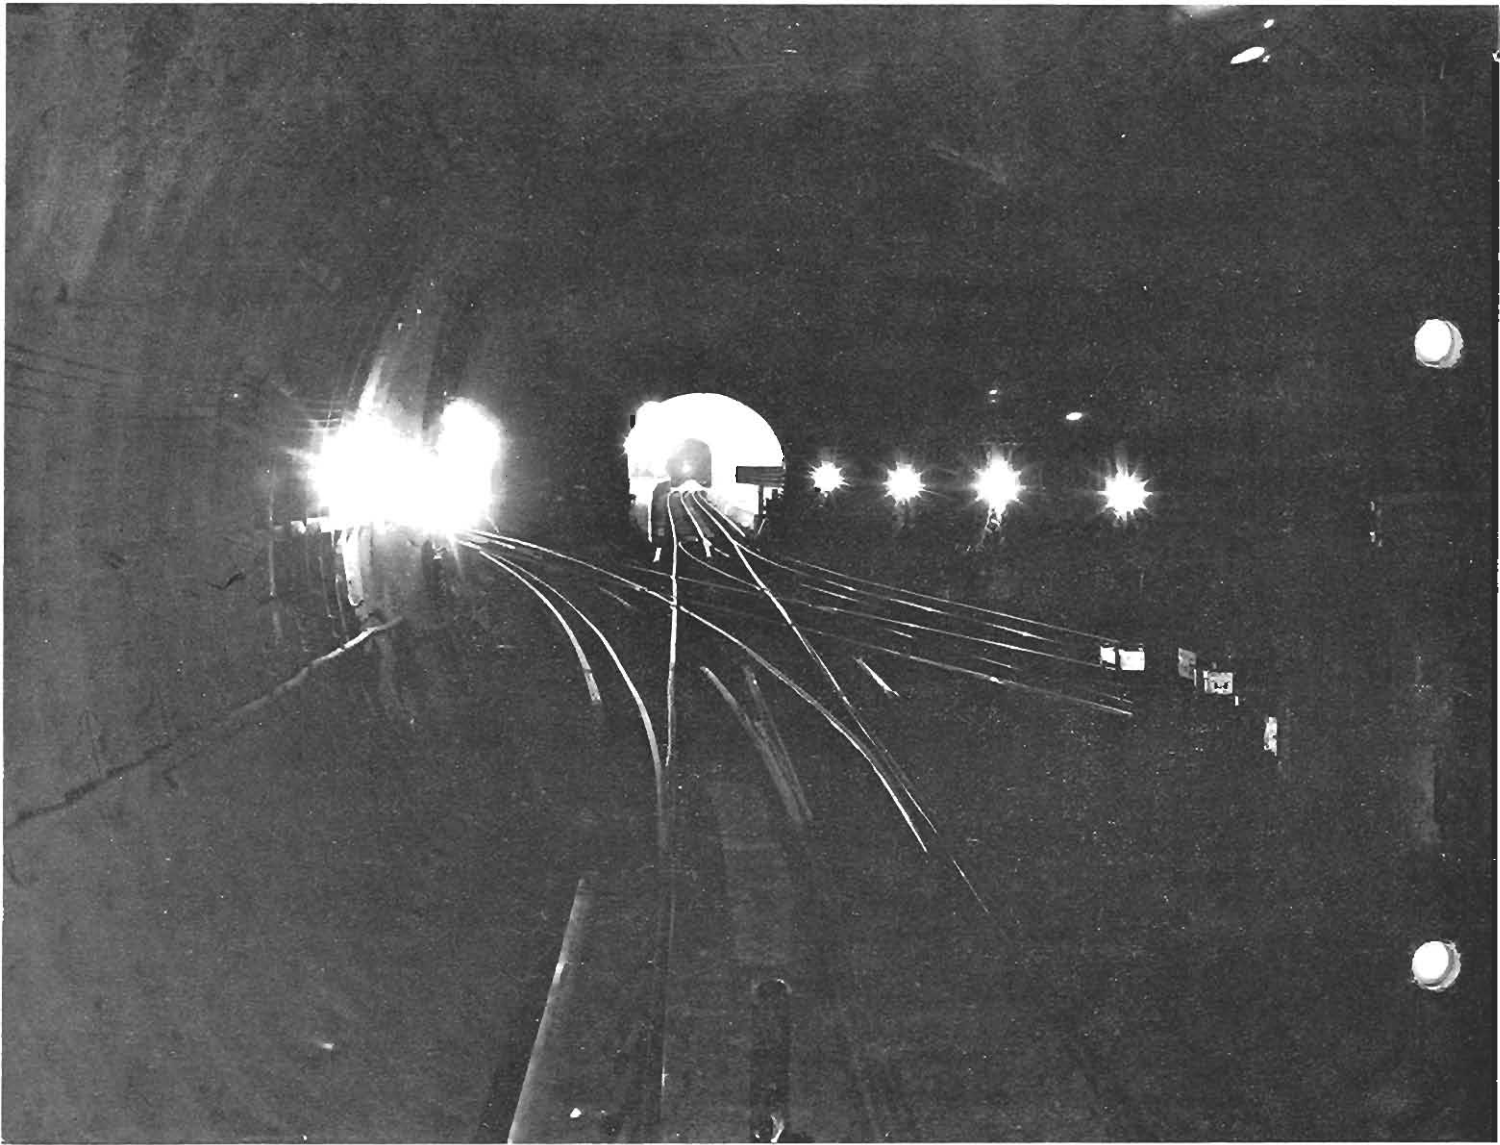
*Photograph 2. View into Platform 9 at Moorgate from Southbound Running Tunnel.  
(By Courtesy of London Transport)*

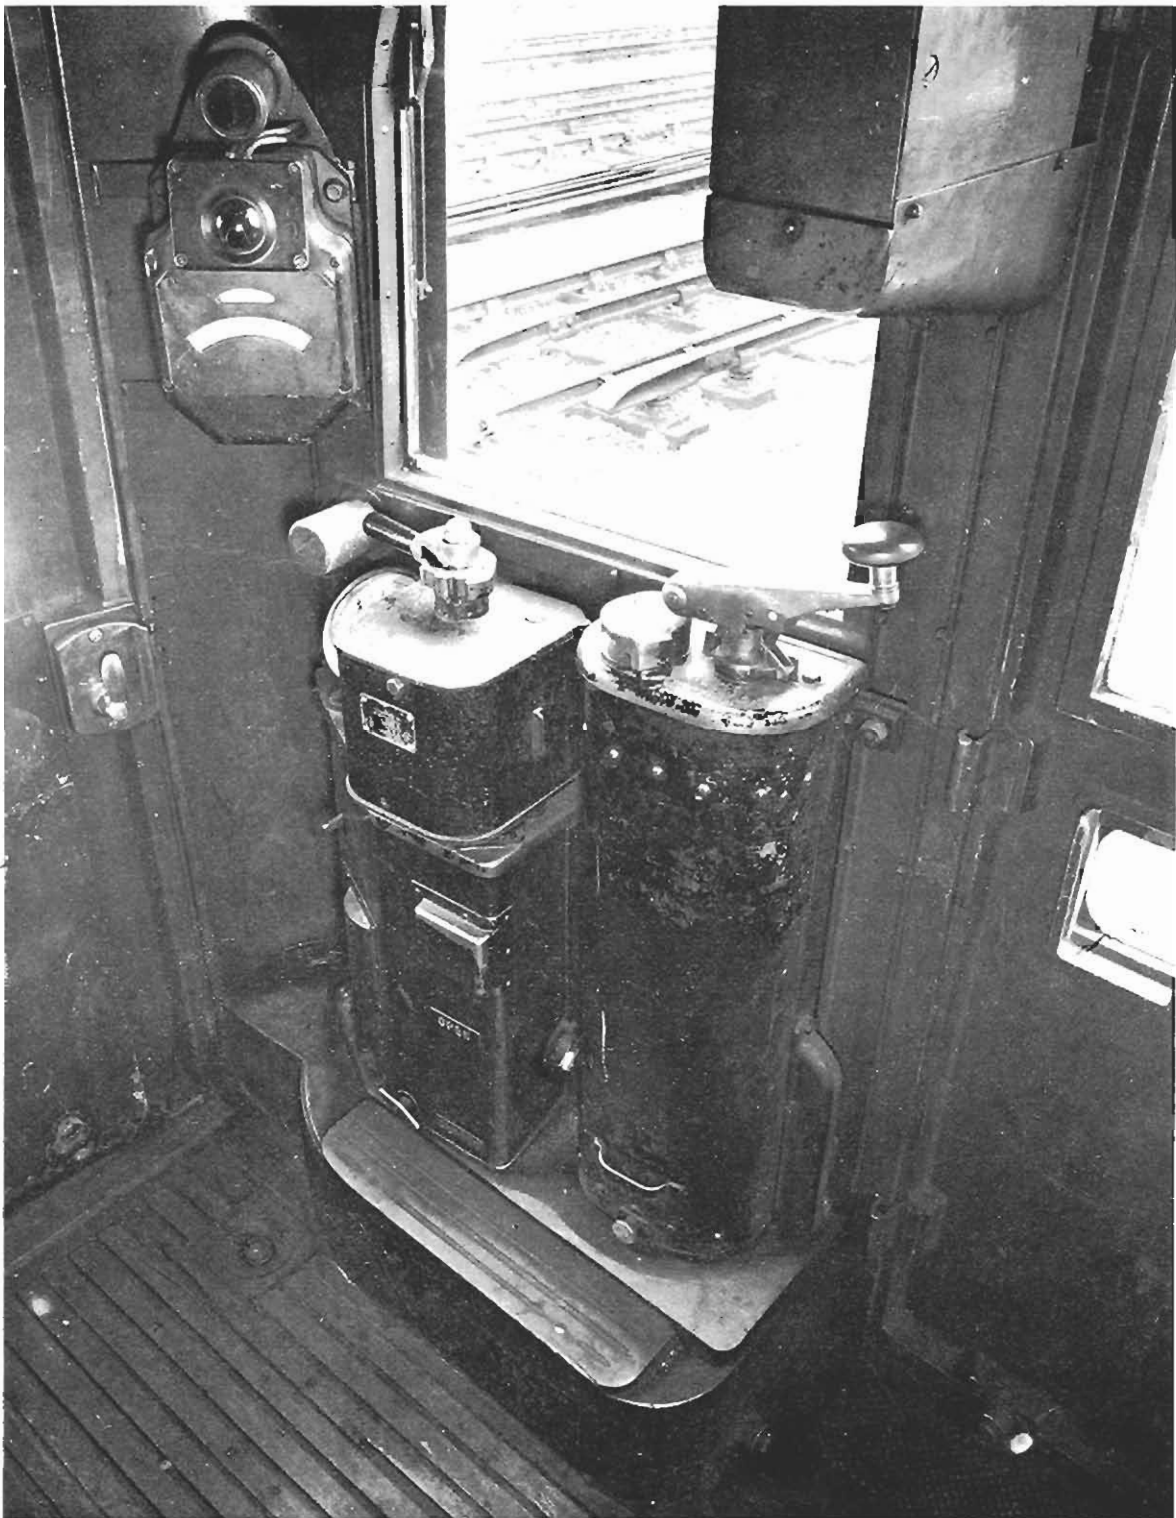
*Photograph 3. Driver's Cab of 1938 Tube Stock, showing, on the left, the Driver's brake handle and, on the right, the Master Controller with the Deadman's handle.  
(By Courtesy of London Transport)*

64. Mr. Lowe told me that, with regard to the brake controls, the cab was found fully operational with all isolating cocks and switches correctly set, though the brake controller itself was quite severely damaged. It was possible, however, to remove all the pneumatic valves associated with the Westinghouse air brake without disturbing them in any way in order to test them. All were found to be functioning correctly when set up on the test panel at Acton Works. They were then fitted to a 6-car train of 1938 stock and again tested and were found to give a satisfactory emergency brake application. The damage to the brake controller was such that the top part which contains the driver's brake handle had broken away from the main body of the controller and in doing so had distorted the operating spindle. This distortion was consistent with the broken handle being in or near the 'Release and Running' position at the time of impact. The brake control handle itself was bent and could not be moved beyond the 'Full Service' position. Test on a similar handle showed that a vertical force of 480 lbs was required to reproduce the same distortion. In Mr. Lowe's opinion the distortion of the brake handle was caused in the collision.

65. The master controller operating handle was found approximately 10° beyond the 'Series' position with the reverser key in the 'Forward 1' position: the controller had been damaged and distorted. Mr. Lowe said that a very close examination had been made of the deadman's mechanism which was found latched with the latching arm broken. It appeared that the damage to the controller caused the reverser key shaft to lift and for the pin valve cam on this shaft to engage with the operating lever either resetting the latch or preventing it from delatching. The fracture of the latching arm was, in his view, a result of the damage caused to the controller in the collision. The fracture was a clean brittle fracture, consistent with the arm having been forced beyond its limit of travel. The part of the deadman's mechanism which interrupts motoring was slightly bent but operational, with the contacts open. There was no defect in the master controller which could have caused it to jam in a motoring position.

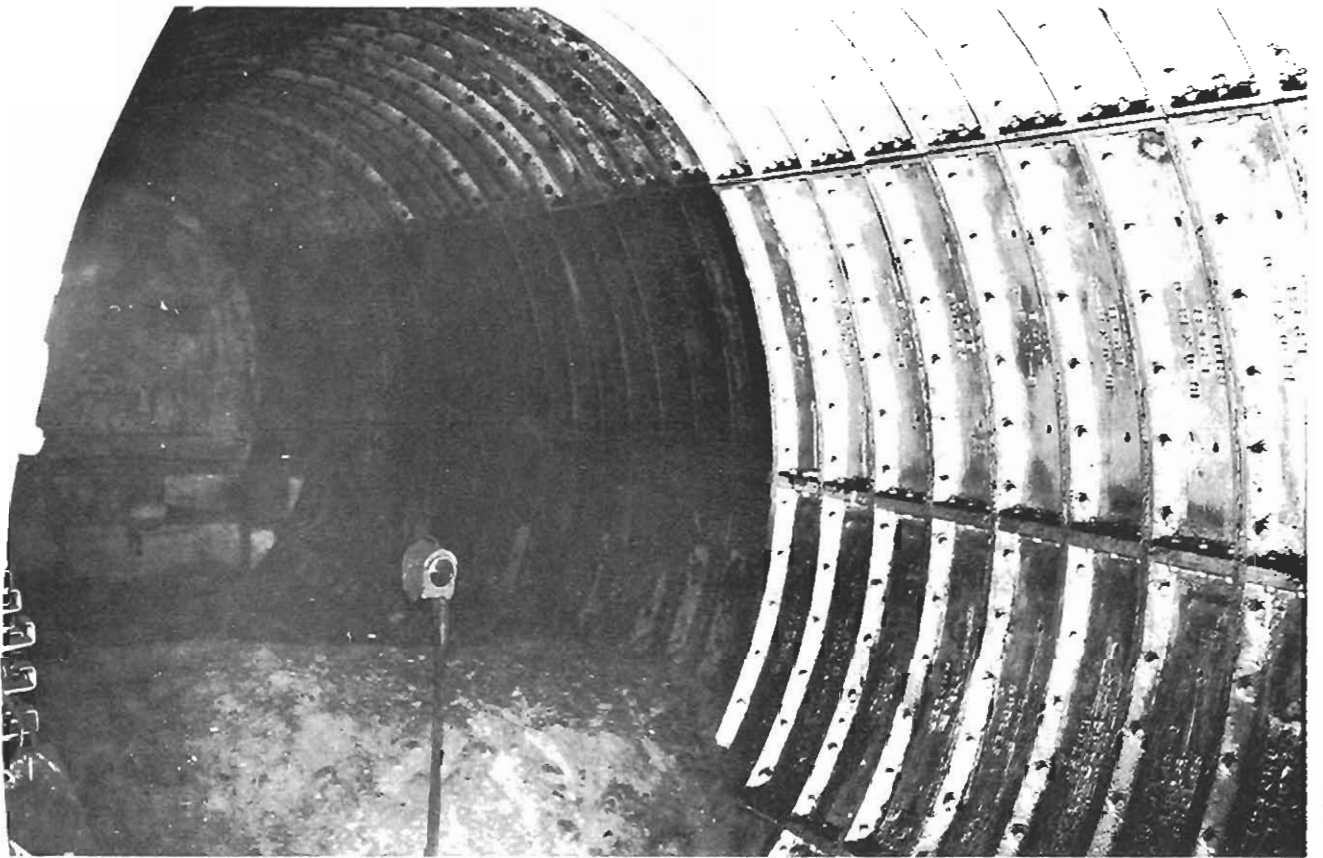
3. Beyond the end of No. 9 platform there was an overrun tunnel 66 ft 9 ins. long ending in a solid end wall. This tunnel was of elliptical cross-section, 16 ft high and 13 ft wide. The track continued into it, on a falling gradient of 1 in 80, as far as a single central hydraulic buffer mounted on a cross-beam extending between concrete blocks against the sidewalls and located about 12 ft from the end wall. This hydraulic buffer was no longer functional but a sand-drag, heaped up to about 2 ft above rail level, had been provided extending from 19 ft outside the overrun tunnel to about 17 ft within it.

*Photograph 4. Platform 9 overrun tunnel as at May 1974. The Sand drag was subsequently lengthened.*

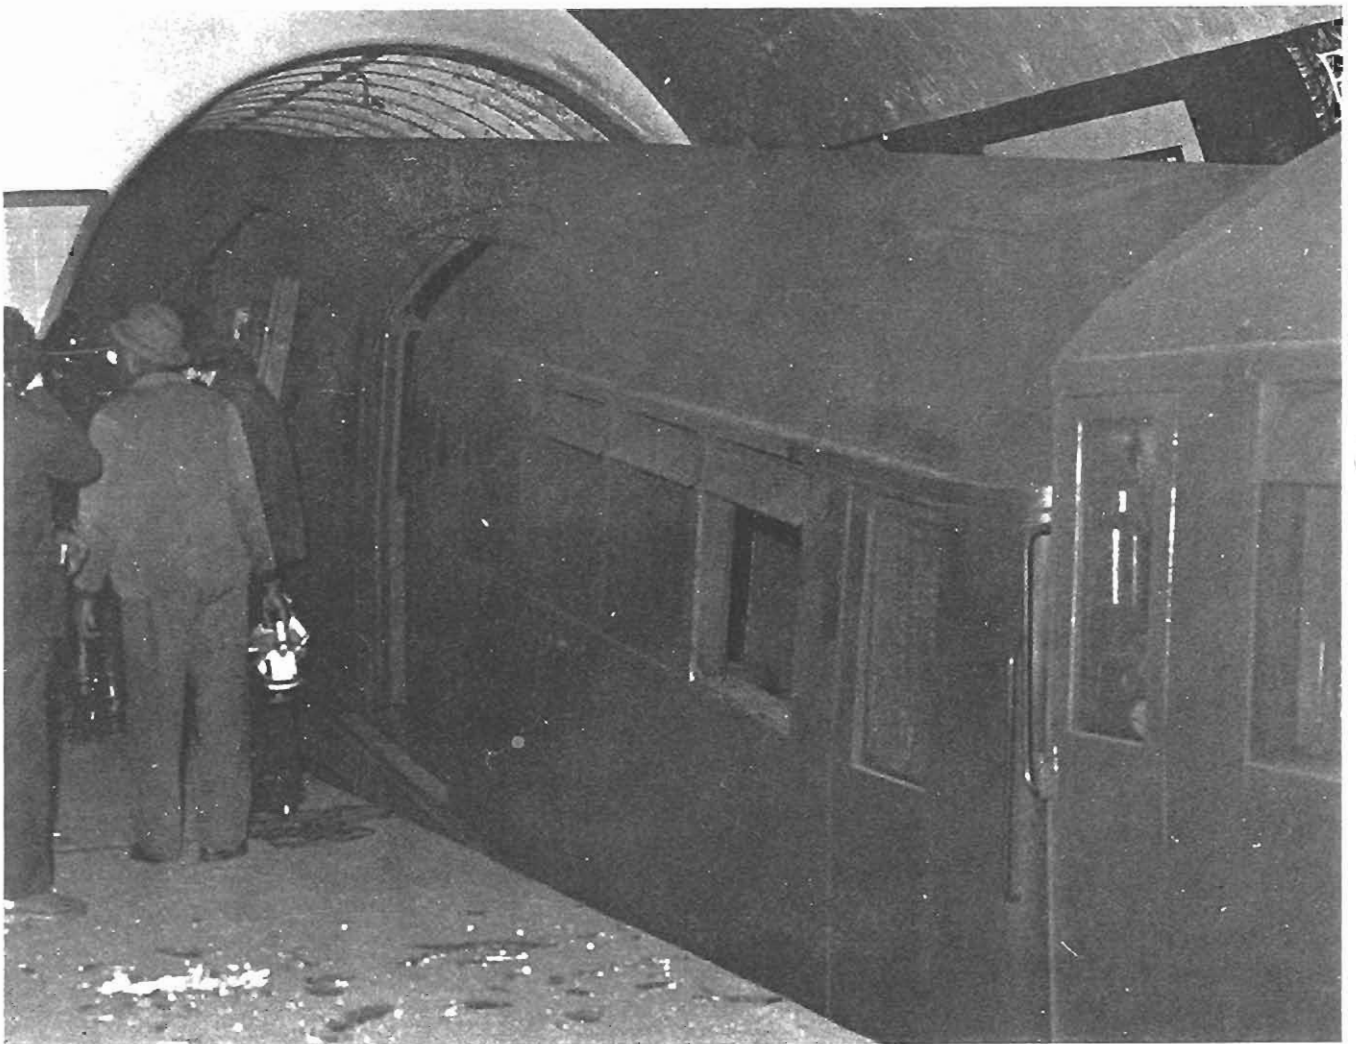
*Photograph 5. Wrecked train showing position of third car.  
(By courtesy of City of London Police)*

116. The immediate cause of the destruction of the two leading cars of the train and the consequential heavy casualty toll was the sudden deceleration imposed on them, the forces involved being far greater than their structures were capable of resisting. In contrast, the absence of damage to the rear three cars indicates that the decelerating forces they experienced were of a level that they could withstand without structural deformation taking place. The approximate distance travelled by the rear of the train after the front hit the buffer stop, the point at which significant deceleration commenced, was 78 ft which, assuming an impact speed of 50 ft/sec, gives an average decelerating force, calculated at the leading end of the fourth car, of about 42 tons, ignoring any contributory braking effect during the period of 3 seconds that the deceleration would have lasted. On the same basis, at the leading end of the third car the force would have been increased to 55 tons, just over the design strength of the underframe, and some small degree of structural deformation in this area could be anticipated and did, indeed, occur.
